# Passed Clearance Report

1140 Wendover Court, Media PA 19063

Inspection Date: August 5, 2026

**Delaware Valley Environmental LLC**

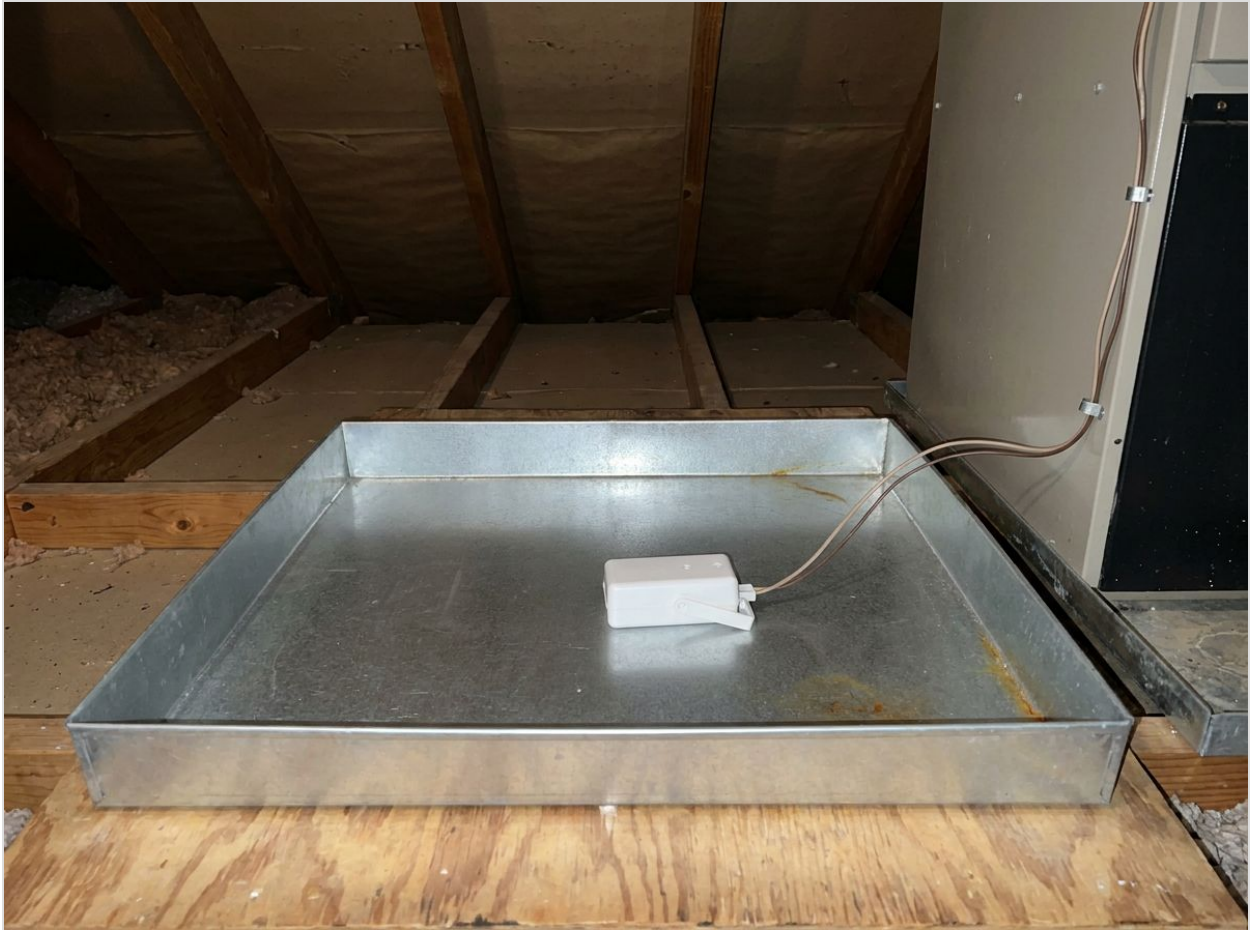
*Secondary condensate drain pan beneath the attic air handler, showing float switch installed and wired to the unit. Rust-orange staining on the pan floor indicates prior water accumulation; pan is dry at the time of this visit.*

The source of moisture identified at the original inspection on July 16, 2026 was overflow from the secondary condensate drain pan of the attic air handler unit. Water migrated from the secondary pan at the NE corner through the platform decking and into ceiling joist bays 2 through 4 beneath the platform, then downward through the blown cellulose insulation and the second-floor ceiling assembly into Bedroom 3 and the adjacent hallway ceiling, and laterally into the west partition wall cavity and down to the carpet pad at the wall base. The intrusion was not active at the time of the original inspection. Corrective HVAC work was performed by Brandywine Heating & Air, LLC under service invoice BHA-41287, dated July 31, 2026. That invoice documents work on the secondary drain pan discharge, installation of a water-level shutoff (float switch), and primary condensate line maintenance. Visual inspection of the secondary pan on this visit confirmed the float switch installed in the pan and wired to the unit, as shown in the photograph of the secondary condensate pan beneath the attic air handler. The pan was dry at the time of this visit. The primary condensate line was observed flowing freely at the original inspection and was serviced per the invoice. The drying goal for this structure, as stated on the moisture survey log, is 13.4% MC or below, derived from the dry standard of 9.4% MC re-established at the north gable rafter tie on this visit. Every pin-type moisture reading taken on wood substrates on this visit falls at or below that goal: the platform decking at the NE corner of the pan read 11.6% MC, the platform decking at center read 10.2% MC, ceiling joist bay 3 beneath the platform read 10.7% MC, ceiling joist bay 2 beneath the platform read 10.4% MC, the top plate at the hallway/Bedroom 3 partition read 10.9% MC, the west wall bottom plate in Bedroom 3 read 12.3% MC, the west wall stud cavity face at 36 in AFF read 10.8% MC, and the subfloor at the west wall base read 11.1% MC. The retained gypsum ceiling board in Bedroom 3 at 4 ft east of the removal line, the retained hallway ceiling board east of the removal line, and the living room ceiling directly below Bedroom 3 were each evaluated by pinless meter and recorded as dry; no numeric values were obtained for those non-wood substrates. No conditions conducive to microbial amplification were observed at any evaluated location on this visit.

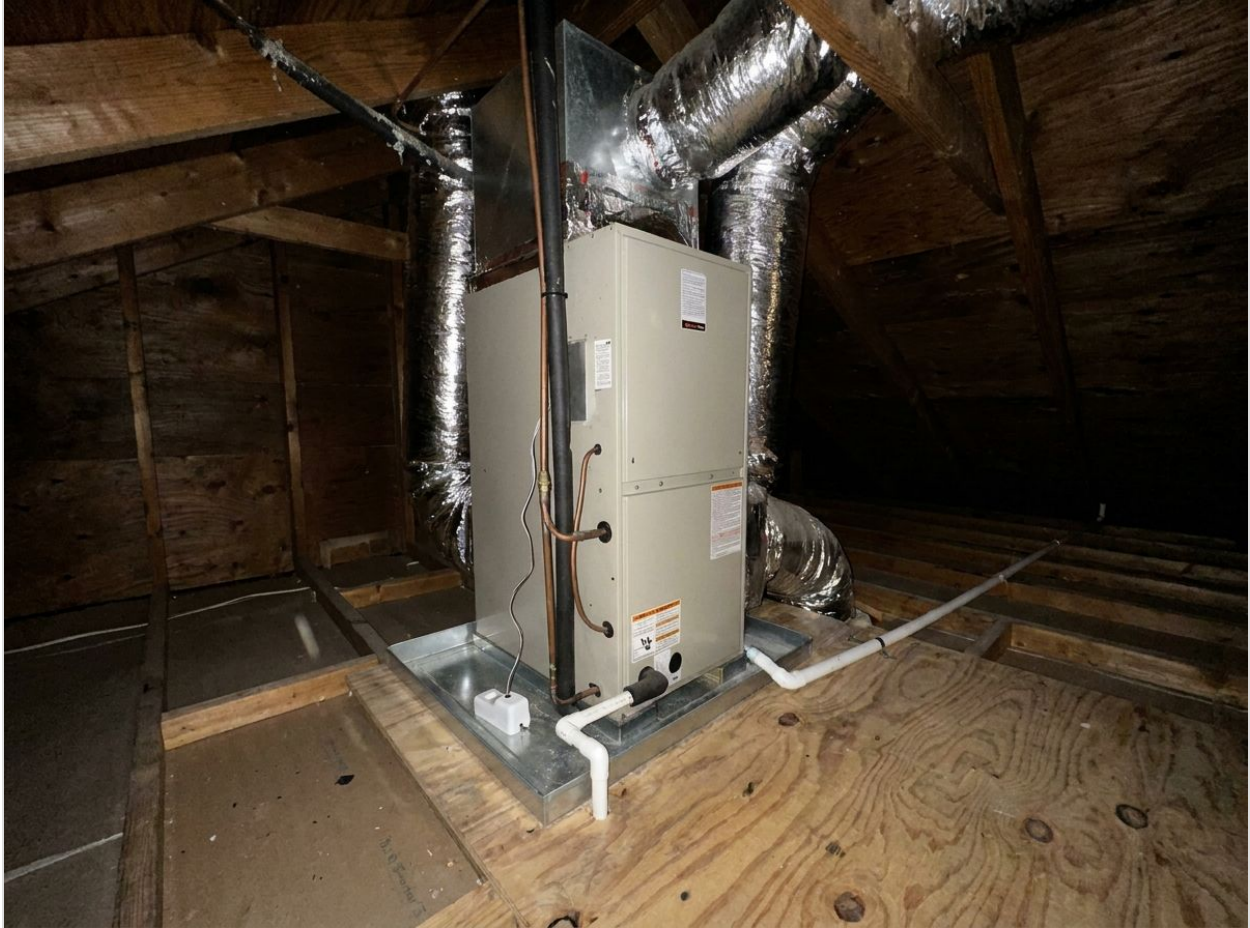
*Attic air handler unit on the equipment platform, showing the galvanized secondary pan, PVC condensate drain lines, and refrigerant line set. No visible mold growth or active water staining observed.*

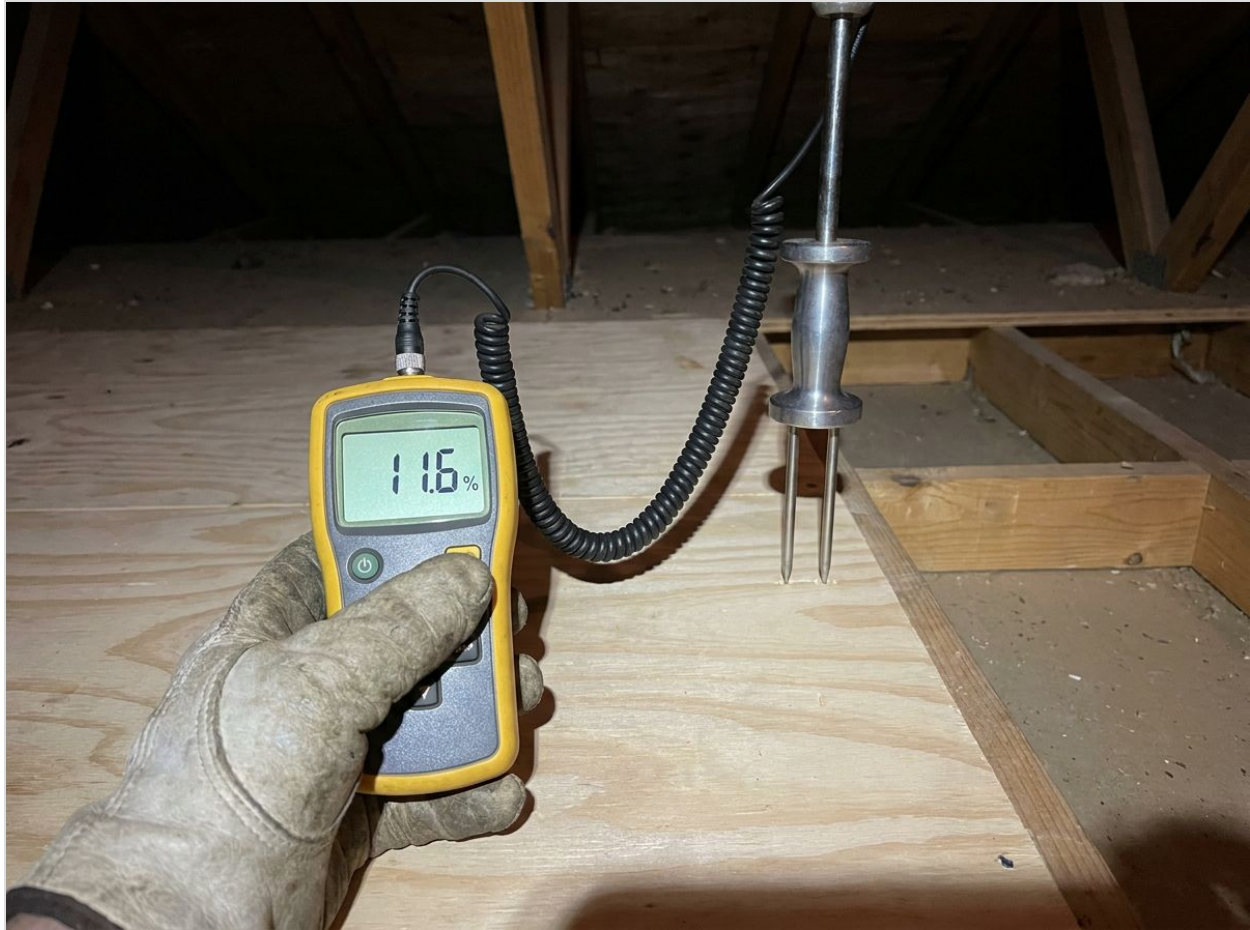
*Pin-type moisture meter probe inserted into platform decking at the NE corner of the secondary pan footprint, reading 11.6% MC, below the drying goal of 13.4% MC.*

| Location | Metric | Previous Visit<br>(July 16, 2026) | This Visit<br>(August 5, 2026) |
|---|---|---|---|
| Attic — platform decking, NE corner of secondary pan | Material moisture content | 26.4% | 11.6% |

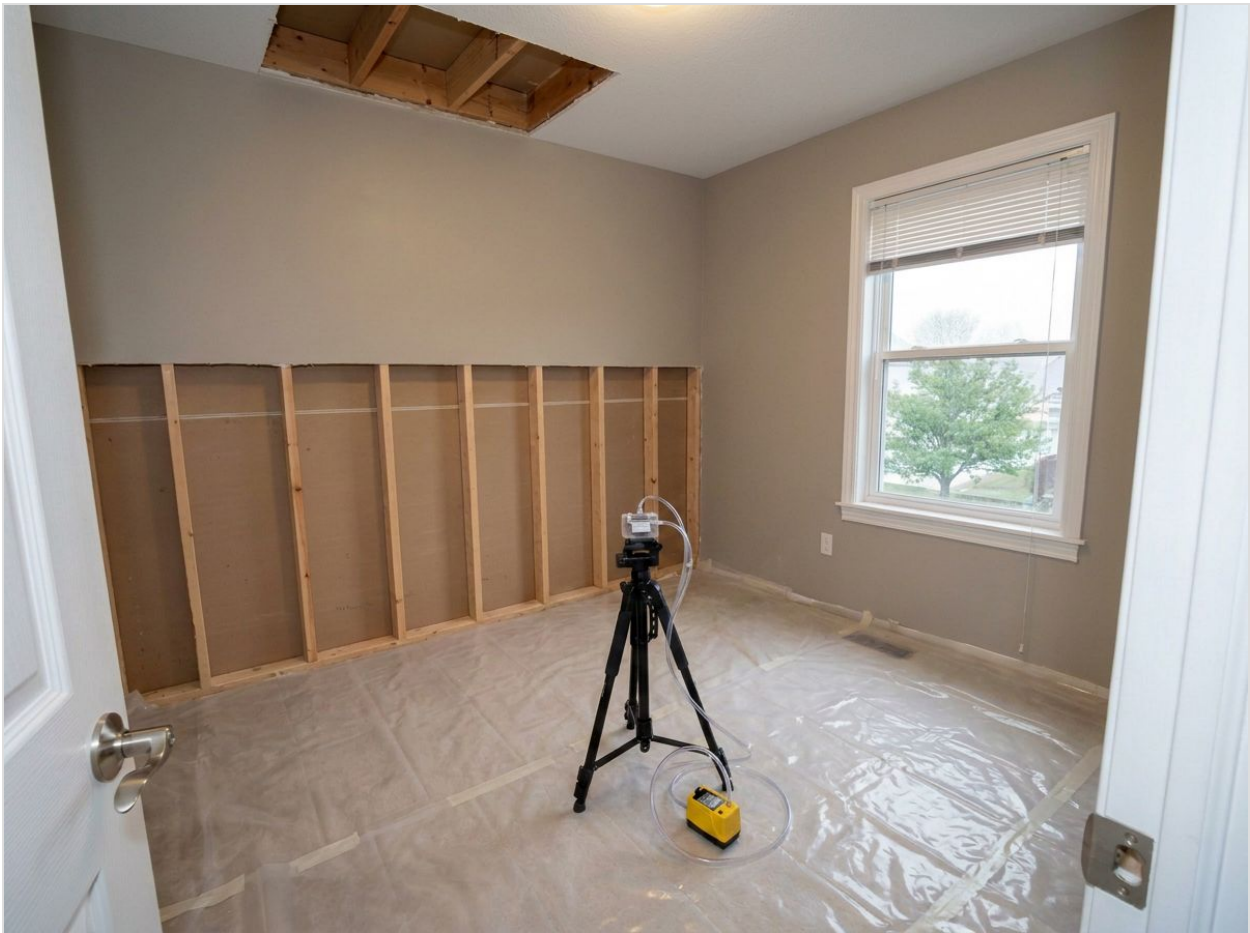
*Bedroom 3 interior showing the post-remediation air sampling setup at center. West wall opened to the framing across the lower portion, ceiling section removed above the platform footprint. No visible mold growth or active water staining on exposed framing or remaining surfaces. Air sampling pump and spore-trap cassette on tripod visible at center.*

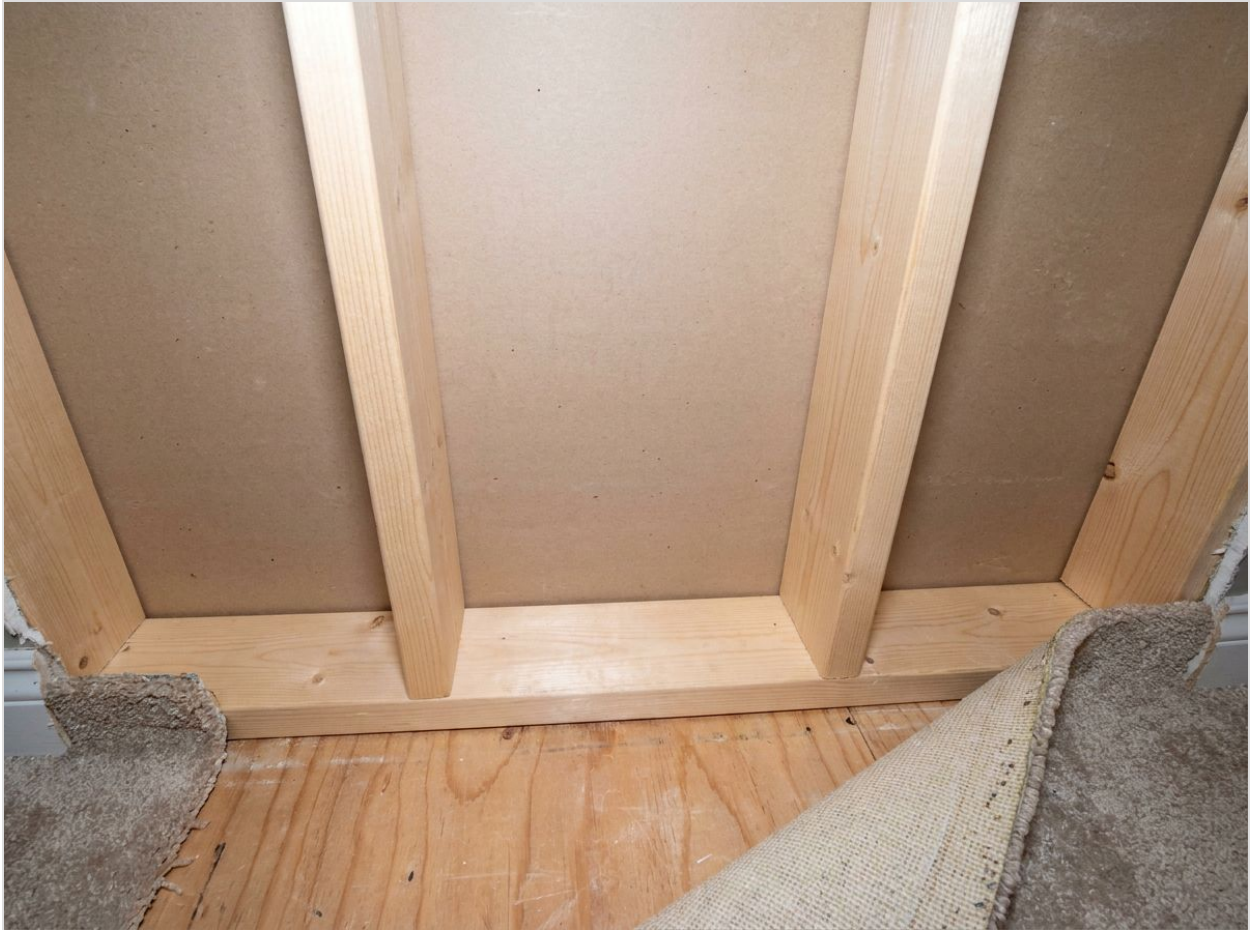
*Low-angle view of the west wall base showing exposed SPF framing, bottom plate, and OSB subfloor after carpet and pad removal. No visible mold growth, staining, or moisture damage on any surface in frame.*

| Location | Metric | Previous Visit<br>(July 16, 2026) | This Visit<br>(August 5, 2026) |
|---|---|---|---|
| Bedroom 3 — west wall bottom plate, bay north of center | Material moisture content | 22.8% | 12.3% |

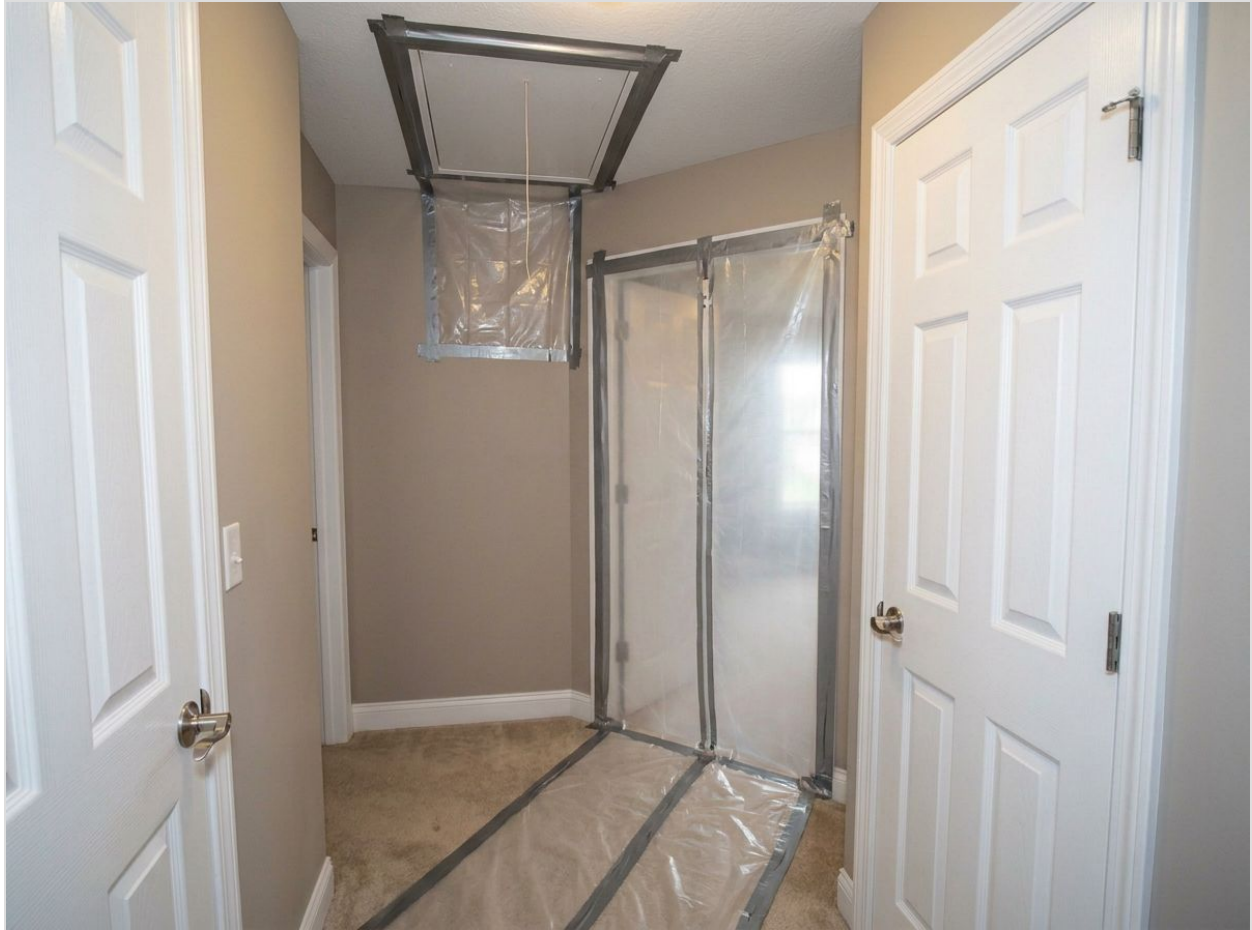
*Upstairs hallway showing the polyethylene containment barrier sealing the Bedroom 3 doorway, with secondary poly covering over the ceiling register overhead. Floor protected with poly sheeting. No mold growth, water staining, or active moisture damage visible.*

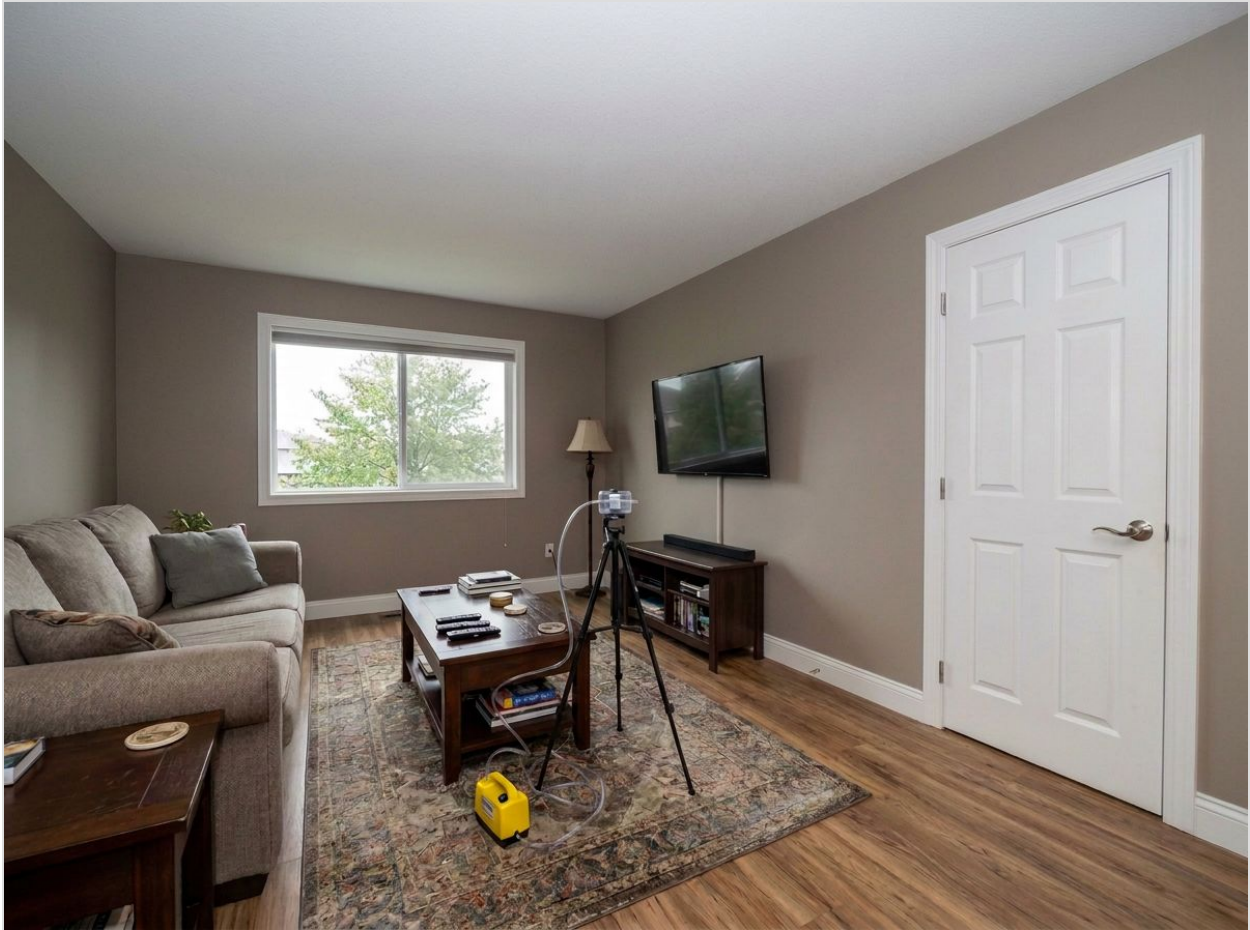
*Living room overview showing air sampling equipment staged at center. No visible mold growth, water staining, or moisture damage observed on ceiling, walls, or floor. The ceiling directly below Bedroom 3 is visible and clean.*

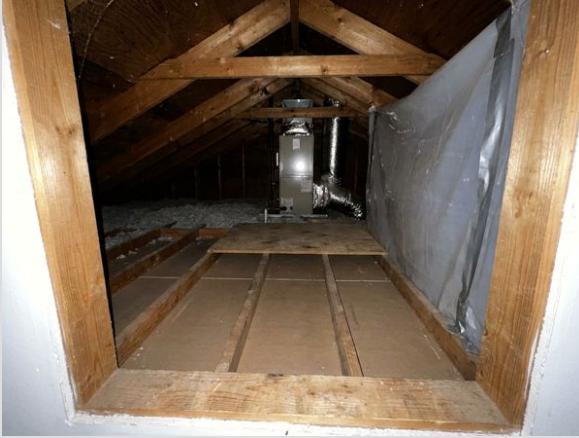
*Attic — view from the scuttle after removal of the affected insulation*

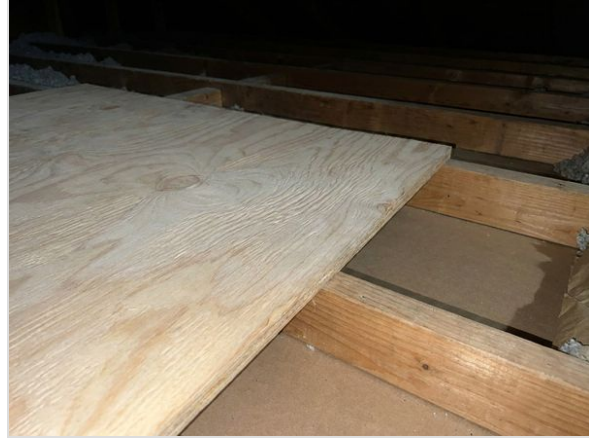
*Attic — platform decking after HEPA vacuuming and damp wiping*

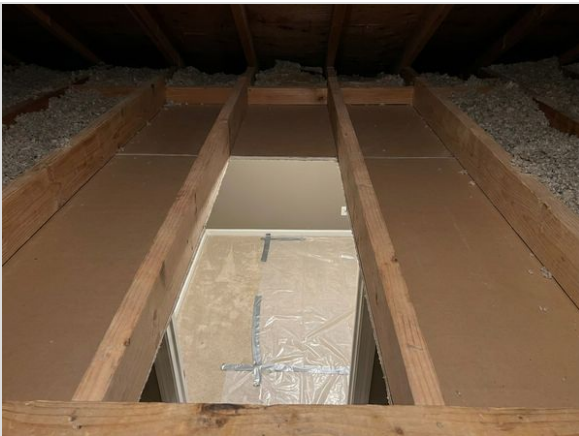
*Attic — ceiling opening into Bedroom 3 after removal of the affected board*

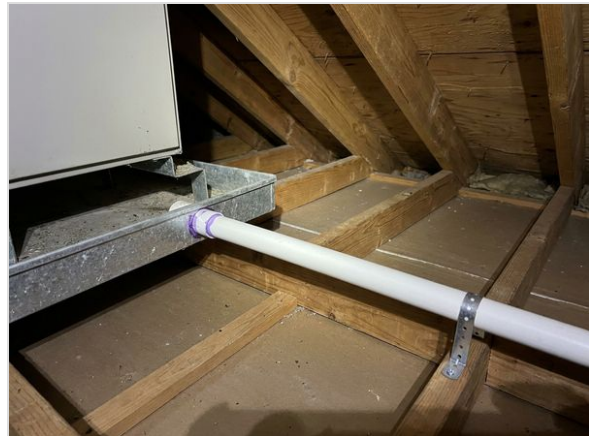
*Attic — secondary pan drain line repiped to a termination*

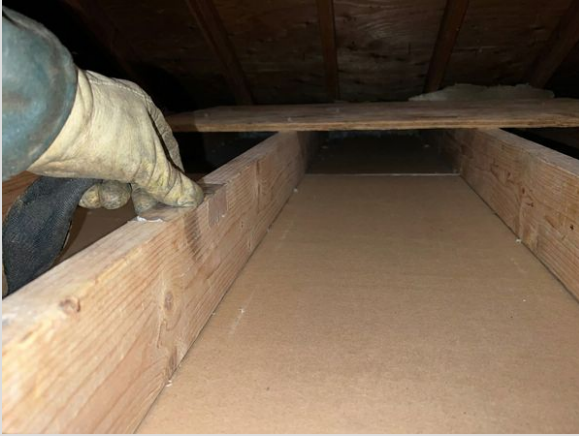
| Sample ID | Species | Result | Outdoor (ct/m <sup>3</sup> ) | Indoor : Outdoor | Interpretation |
|---|---|---|---|---|---|
| S-306 | Chaetomium sp. | None detected | Not applicable | Not applicable | Not detected on the cleaned attic-side ceiling joist and platform decking at the NE corner of the pan footprint. The original inspection recorded Chaetomium sp. at a heavy semi-quantitative rating on the attic-side ceiling drywall paper facing at the stain margin on July 16, 2026. The current result confirms no Chaetomium sp. remains on the cleaned wood substrate at this location. |

| Sample ID | Species | Result | Outdoor (ct/m <sup>3</sup> ) | Indoor : Outdoor | Interpretation |
|---|---|---|---|---|---|
| S-306 | Stachybotrys chartarum | None detected | Not applicable | Not applicable | Not detected on the cleaned attic-side ceiling joist and platform decking. The original inspection recorded Stachybotrys chartarum at a moderate semi-quantitative rating on the attic-side ceiling drywall paper facing at the stain margin on July 16, 2026. The current result confirms no Stachybotrys chartarum remains on the cleaned wood substrate at this location. |

*Attic — surface tape lift S-306 on the cleaned ceiling joist and platform decking*

**Analyst note on S-306.** Structures observed were dispersed individual spores consistent with settled background. No fungal structures indicative of growth in situ — conidiophores, hyphal networks or colonies — were observed on this sample.

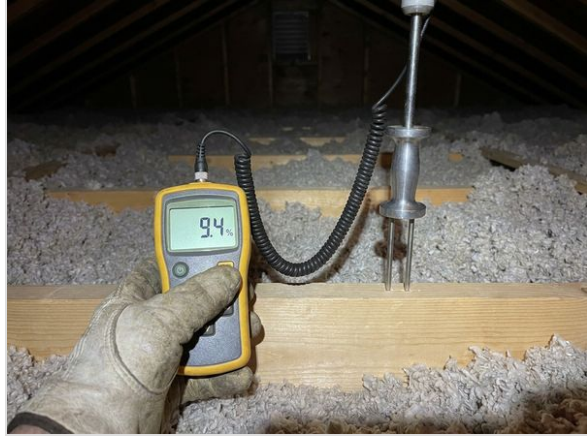
*Attic — north gable rafter tie, re-established as the project dry standard*

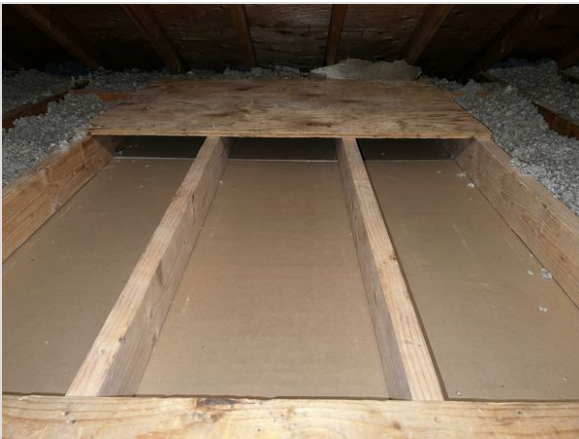
*Attic — ceiling joist bays stripped of insulation and cleaned*

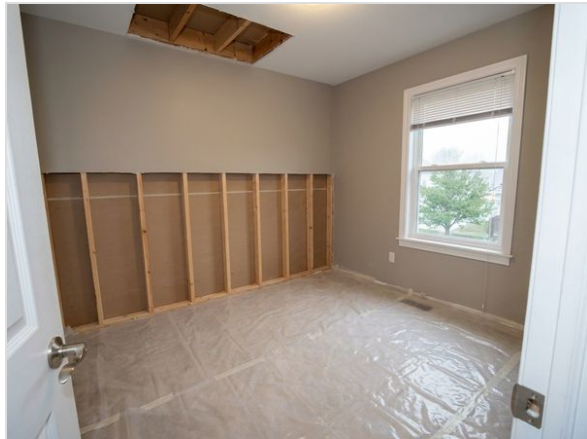
*Bedroom 3 — affected materials removed, framing and wall cavity exposed*

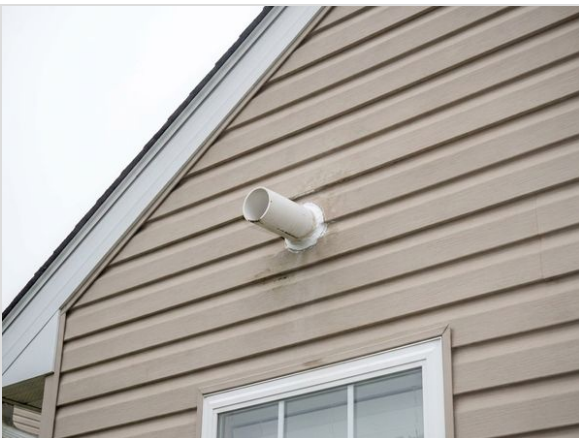
*Exterior — new secondary condensate discharge termination*
