# Mold Assessment Report

247 Maplewood Drive, Bridgeport CT 06606

Inspection Date: May 4, 2026

**B&A Consulting LLC**

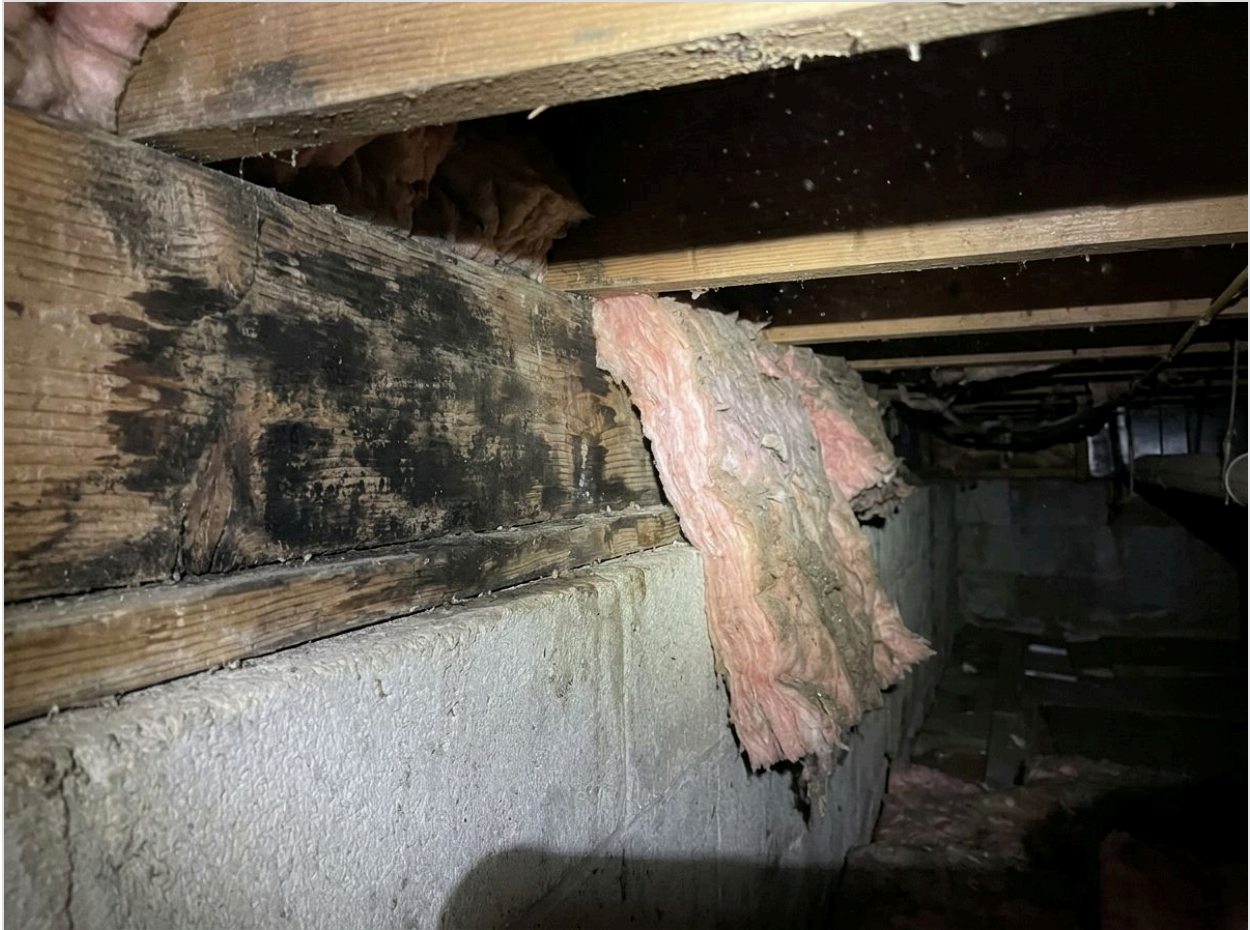
The crawlspace was accessed via the north floor hatch. The interior access hatch panel was fitted with a mechanical fan/blower unit, and a Buck air sampling pump was positioned at the hatch opening for collection of sample S-005. The north half of the crawlspace floor exhibited a partial vapor barrier. The south half of the crawlspace floor remained exposed dirt, a pre-existing deficiency documented in the September 2024 Enviro-Check inspection and not corrected prior to this loss event. At the south rim joist area, directly beneath the master bedroom east wall, the inspector observed extensive dark black and brown discoloration on the sill plate and band joist lumber consistent with active fungal colonization. The staining extended across approximately a 4-foot run of the south rim joist framing. Fiberglass batt insulation in the south joist bays was observed sagging, wet to the touch, and visibly soiled. The kraft paper facing of the insulation exhibited discoloration and deterioration consistent with prolonged wetting. A pin moisture reading on the insulation paper backing at the south rim registered 47% WME, a saturated status that exceeds the instrument's reliable resolution range. The floor joist at the south end registered 24% WME, elevated and exceeding the IICRC S500 drying standard of 16% WME for wood framing. Both readings exceed the ASHRAE 160 threshold for sustained microbial amplification conditions. The air sample collected at the north access hatch (S-005) returned a total count of 18,650 ct/m<sup>3</sup>, representing 9.4x the outdoor baseline. *Penicillium* spp. was detected at 12,800 ct/m<sup>3</sup> (absent outdoors), *Aspergillus/Penicillium*-like at 4,200 ct/m<sup>3</sup> (17.5x outdoor), *Stachybotrys* at 580 ct/m<sup>3</sup> (absent outdoors), and *Aureobasidium* at 380 ct/m<sup>3</sup> (absent outdoors). The tape lift surface sample (S-006) collected from the south rim joist insulation confirmed *Aspergillus niger* at 4+ (heavy), *Stachybotrys chartarum* at 3+ (moderate-heavy), and *Penicillium* spp. at elevated levels. Water migration from the supply line failure above is the identified pathway for moisture entry into this space. The active moisture intrusion combined with the pre-existing exposed south floor creates compounded amplification conditions. Per IICRC S520-2024 Section 12, this area is classified as Condition 3.

*Extensive black and brown fungal discoloration on the sill plate and band joist at the south rim, consistent with active mold colonization. Displaced fiberglass batt insulation and concrete block foundation wall visible. Conditions consistent with IICRC S520-2024 Condition 3.*

3. IMMEDIATE: Remove all fiberglass batt insulation from the south crawlspace rim joist bays and affected joist cavities. Treat framing and rim joist surfaces with HEPA vacuuming followed by antimicrobial application per IICRC S520-2024 Condition 3 requirements. Do not remediate without full containment and appropriate PPE per OSHA 29 CFR 1926 Subpart E.

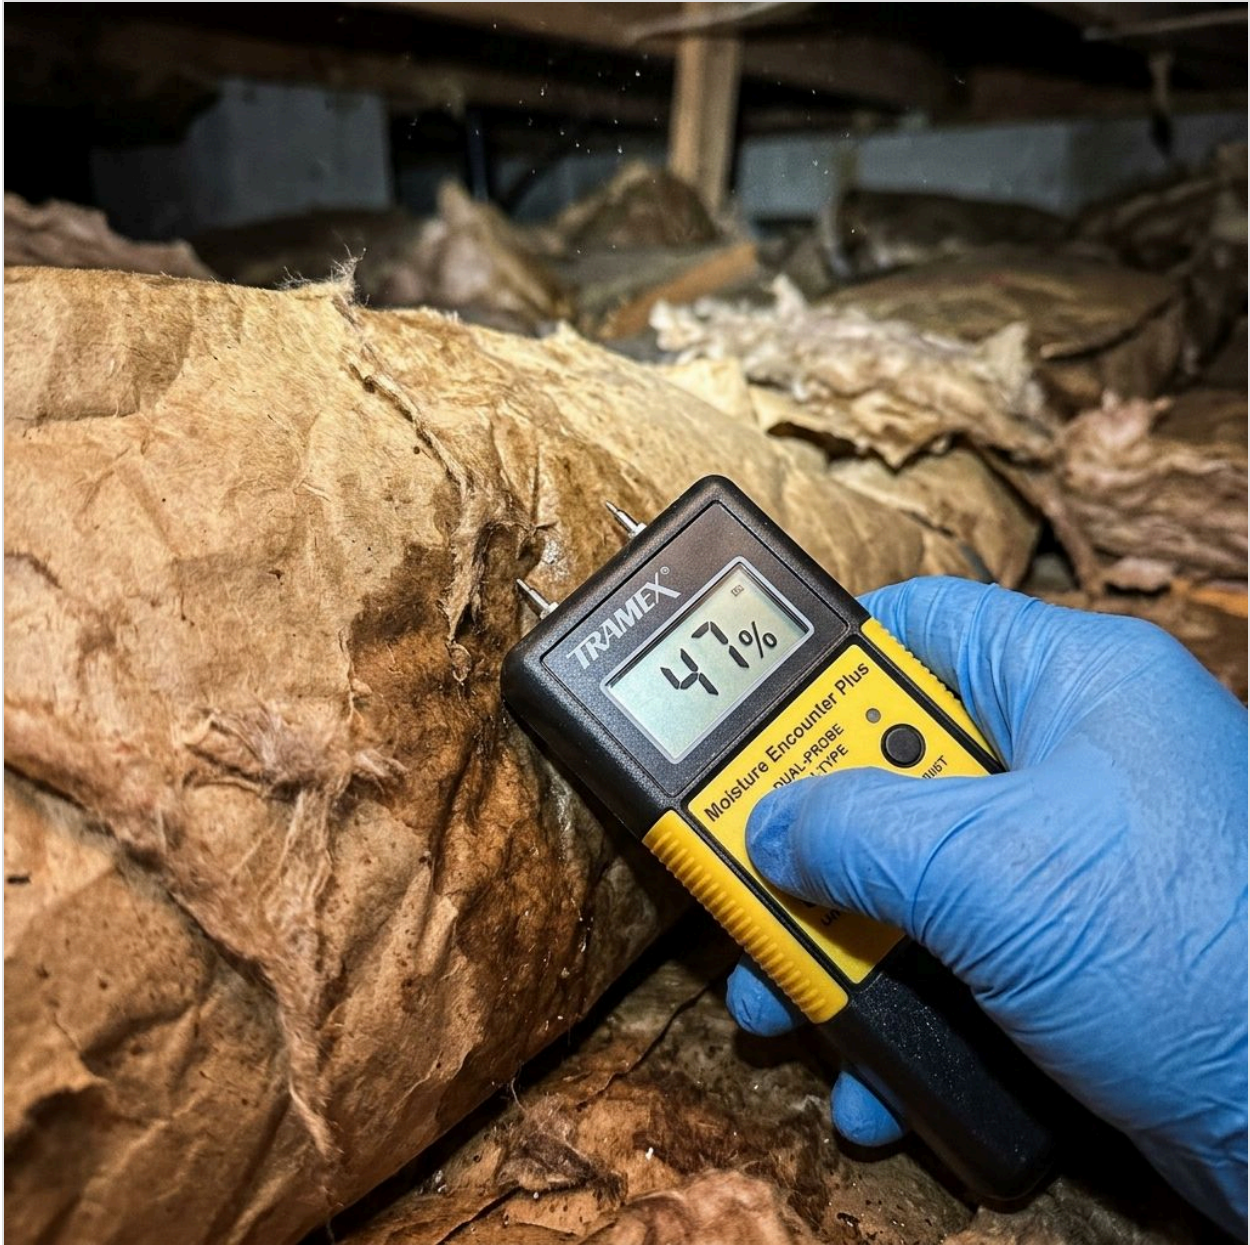
*Pin moisture reading of 47% WME on degraded kraft-faced insulation at the south crawlspace rim joist. Reading exceeds the instrument's reliable upper range. Insulation shows significant staining and deterioration consistent with prolonged wetting.*

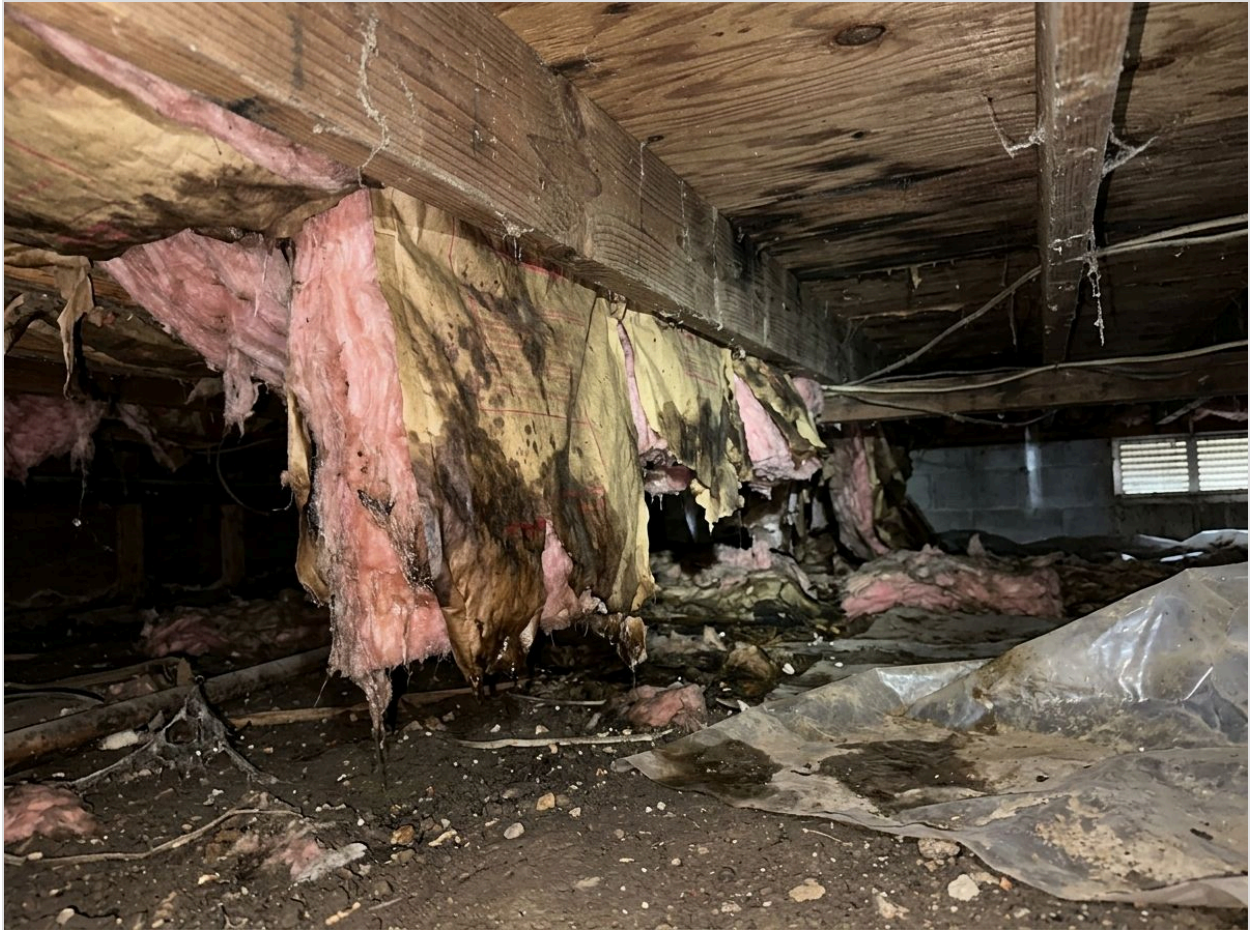
*Fallen and sagging fiberglass batt insulation with dark brown to black fungal growth on kraft paper facing and subfloor decking. Active moisture dripping observed. Partial vapor barrier present on north floor only. Condition 3 per IICRC S520-2024.*

6. **SHORT-TERM:** Install a continuous polyethylene vapor barrier across the entire crawlspace floor including the south exposed-dirt half, per the recommendation from the September 2024 Enviro-Check inspection. This deficiency contributed to elevated baseline moisture in the crawlspace and must be corrected as part of the remediation scope.

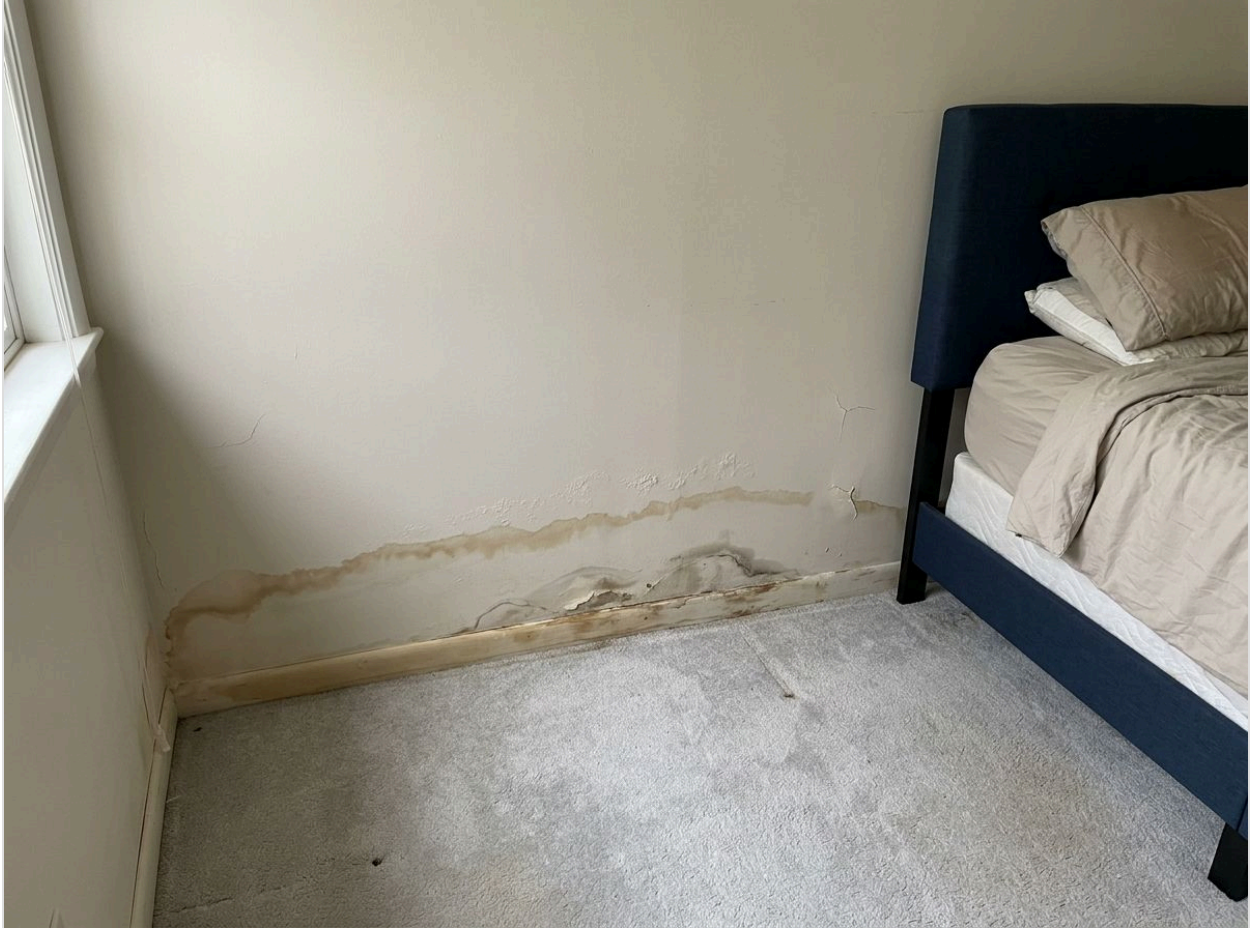
*Tideline water staining with tan/brown discoloration extending approximately 18 to 24 inches up the east drywall adjacent to the window. Dark brown to black discoloration at the baseboard junction consistent with mold growth. Paint bubbling and delamination above the tideline. Carpet discoloration indicates prolonged moisture migration.*

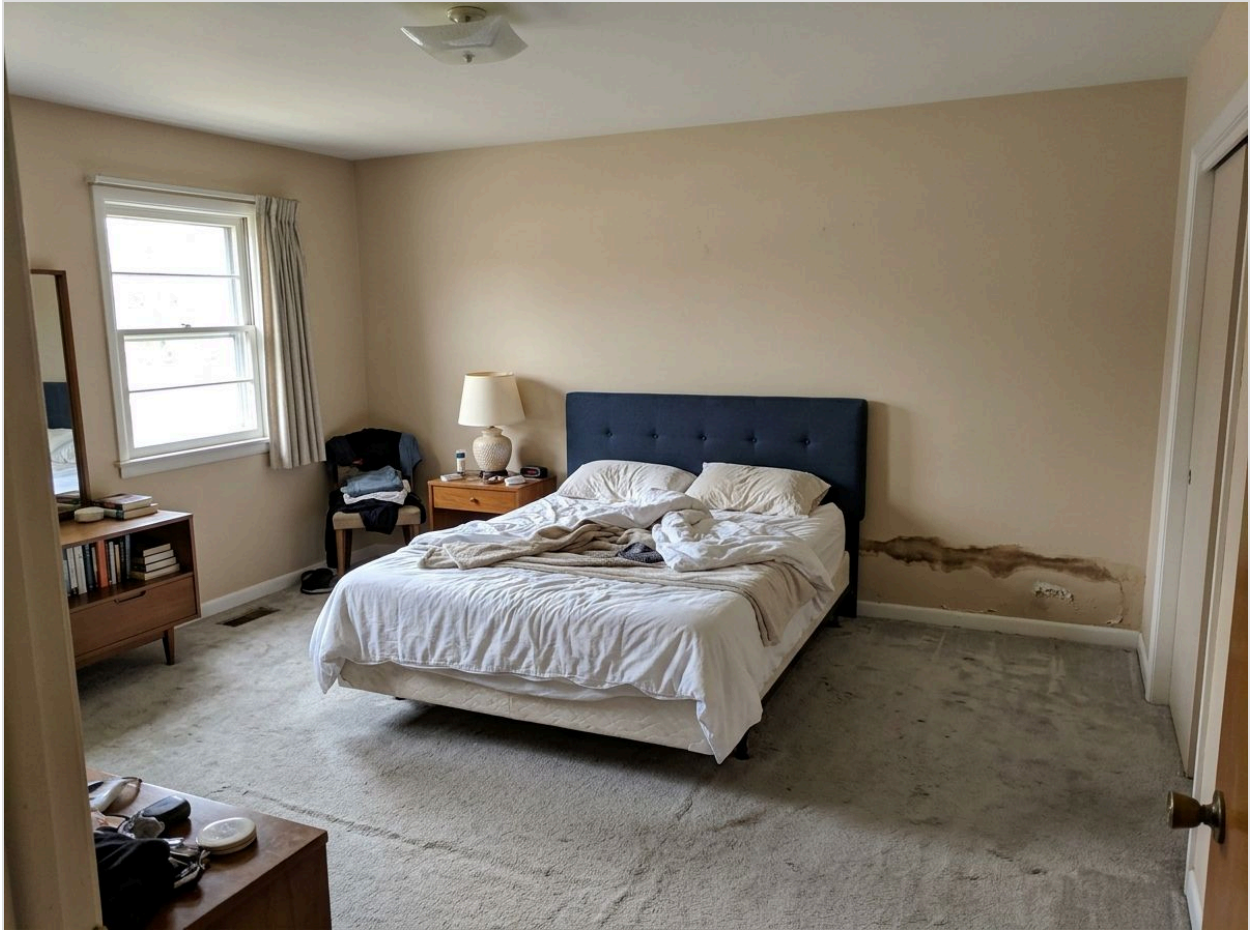
*Brown water staining on the lower east wall, extending approximately 3 to 4 feet wide and 12 to 18 inches above the baseboard. Tideline demarcation and carpet discoloration consistent with chronic moisture intrusion at the wall base.*

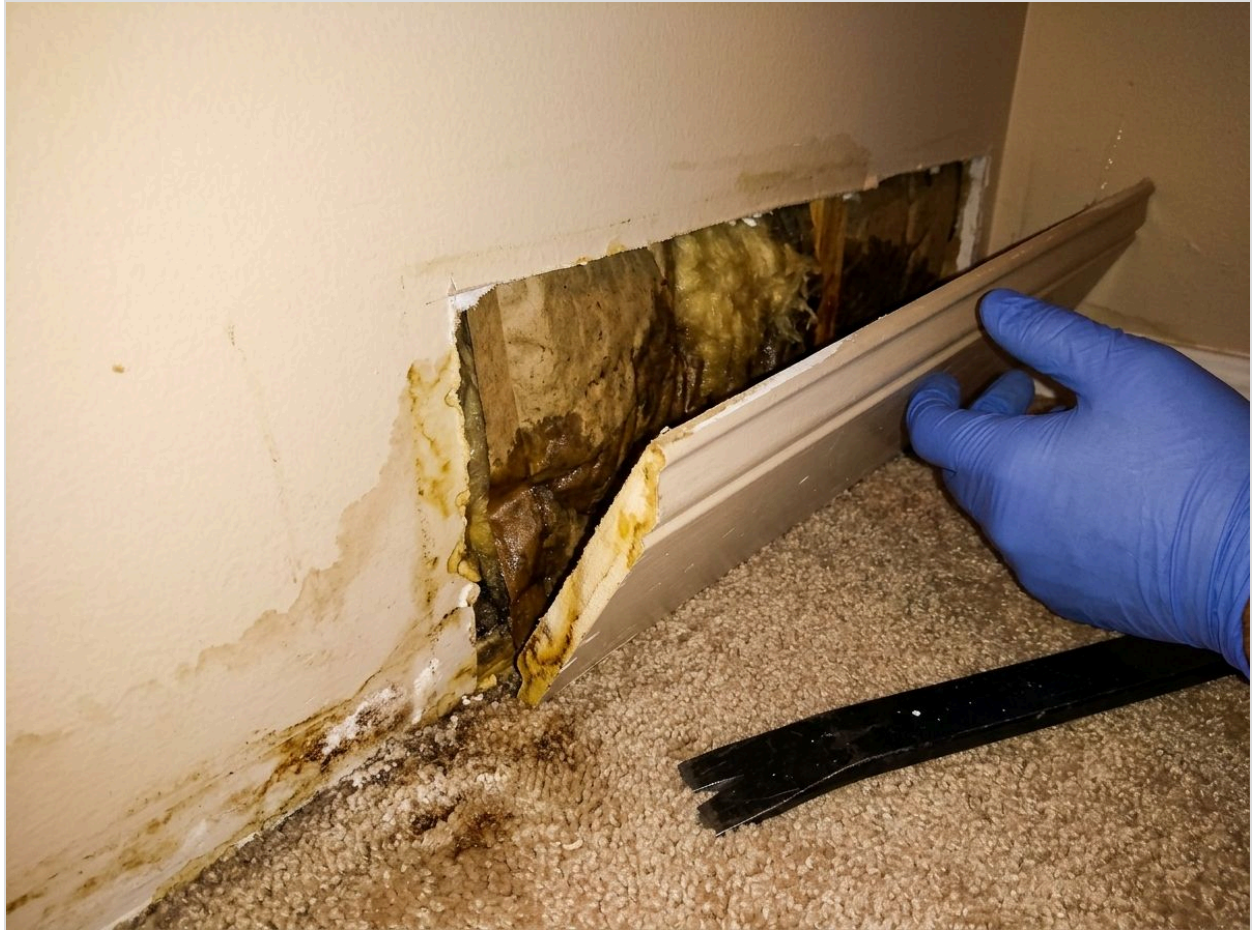
The master bedroom occupies the area directly above the south crawlspace. The washing machine is located on the east interior wall. Following the supply line failure on approximately April 15, 2026, water migrated into the east wall cavity and downward through the floor assembly. The homeowner reported initial drying by mopping and box fans for approximately 24 hours, after which no further mitigation was performed. Visual inspection of the east wall baseboard identified brown water staining extending approximately 3 to 4 feet wide along the lower east wall, with a tideline pattern consistent with wicking from the base of the wall. At a separate east wall location adjacent to the window, dark brown to black discoloration at the lower wall-to-baseboard junction was observed, with paint bubbling, delamination, and carpet discoloration extending outward from the base. These observations are consistent with chronic or recurring wetting within the wall cavity. Removal of the baseboard in the affected area (documented at a separate room location also attributable to this wall cavity) revealed fungal colonization on the back face of the gypsum wallboard and OSB sheathing, with black and dark brown growth at the cavity base, yellow-brown vertical water staining on the gypsum paper facing, and white mycelial growth at the carpet-wall interface. A pin moisture reading at the east wall baseboard (washer wall) registered 32% WME on the baseboard substrate. This reading is classified as saturated and exceeds the ASHRAE 160 microbial amplification threshold. The exterior wall midpoint registered 9.2% WME (normal), and the floor near the closet registered 11.4% WME (normal), indicating the moisture impact is localized to the east wall cavity. The air sample collected in the master bedroom (S-002) returned *Stachybotrys* at 220 ct/m<sup>3</sup>, absent from the outdoor control, and *Aspergillus*/*Penicillium*-like at 1,840 ct/m<sup>3</sup>, 7.7x the outdoor level. These findings are consistent with upward migration of contaminated air from the crawlspace through the shared wall cavity. The homeowner reported headaches and nasal congestion in this space over the 10 days prior to inspection, and both occupants relocated to the guest bedroom as of April 29. Per IICRC S520-2024 Section 12, this area is classified as Condition 3.

*Baseboard removed to reveal fungal colonization on the back face of gypsum wallboard and OSB sheathing. Black and dark brown growth at the wall cavity base. White mycelial growth at carpet-wall interface. Yellow-brown vertical staining on gypsum paper facing consistent with wall-cavity wetting.*

4. SHORT-TERM: Open the master bedroom east wall cavity from the interior to expose the wall cavity, remove all saturated and contaminated drywall and baseboard below the splash line, and

initiate structural drying using dehumidification and airflow. IICRC S500 drying standard of less than 16% WME for wood framing must be achieved and verified prior to reconstruction.

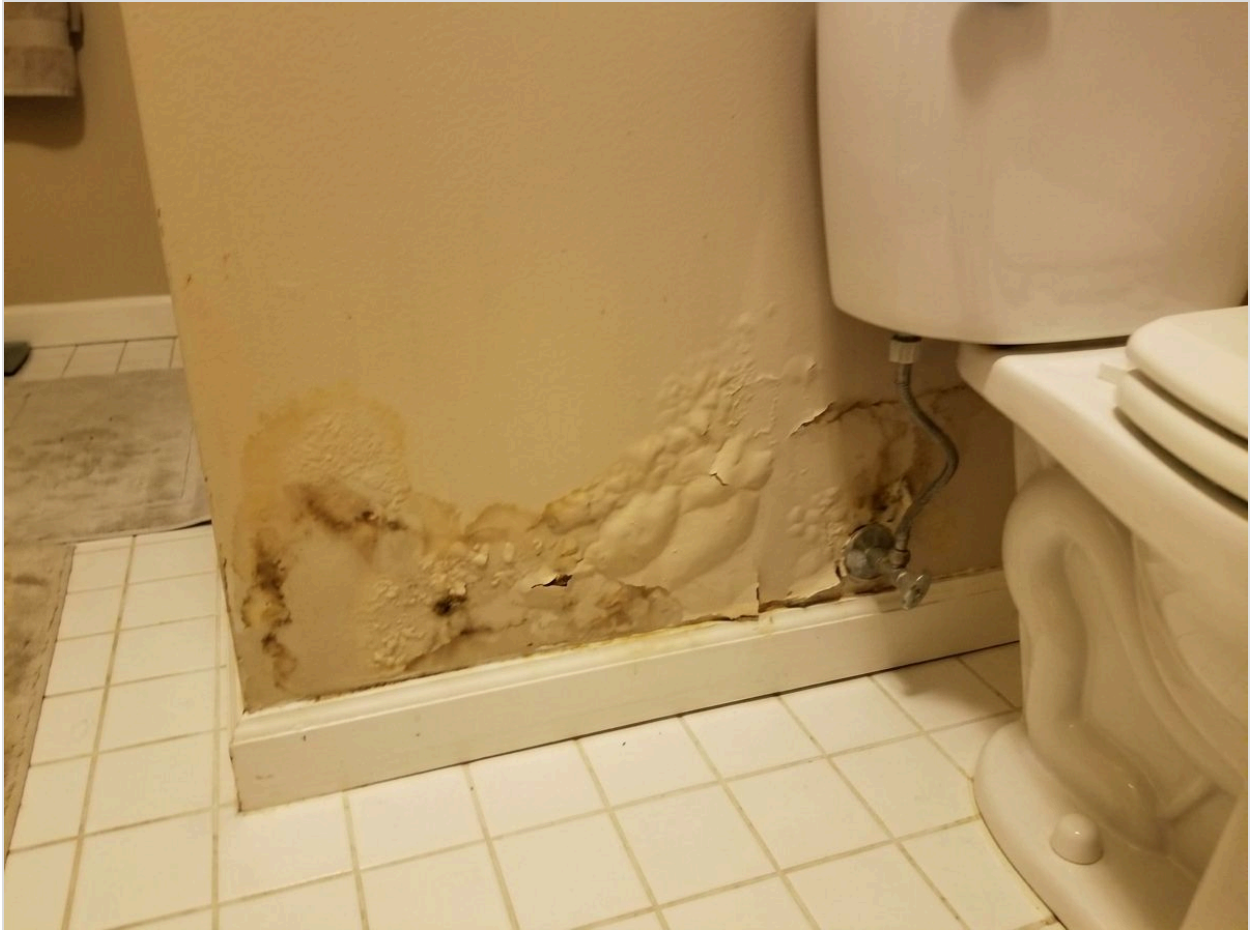
The master bathroom adjoins the master bedroom and shares the east wall cavity. Visual inspection behind the toilet identified significant paint bubbling, peeling, and drywall surface delamination at the lower wall section adjacent to the toilet supply line and baseboard. Dark brown to black discoloration consistent with microbial growth was observed beneath the peeling paint at the wall-floor junction. Tan/yellow water staining on the surrounding wall surface indicates chronic moisture intrusion, likely originating from a slow leak at the toilet supply valve or ongoing condensation accumulation at that location. Pin moisture readings in this area returned 28% WME on the drywall behind the toilet, a saturated reading that exceeds ASHRAE 160 thresholds for microbial amplification. The subfloor near the tub registered 14% WME, which is elevated but within the borderline range for normal wood substrates. The tile grout on the shower wall registered 6% WME, normal and without concern. The air sample collected in the master bathroom (S-003) returned *Aspergillus/Penicillium*-like at 920 ct/m<sup>3</sup>, 3.8x the outdoor baseline, with all other species within the outdoor range. The elevated ratio at this location, while not as pronounced as in the master bedroom or crawlspace, indicates a secondary moisture condition contributing to fungal amplification independent of the primary supply line event. The 28% WME reading behind the toilet warrants investigation for a separate moisture source at the toilet supply connection. Per IICRC S520-2024 Section 12, the area behind the toilet is classified as Condition 3 based on saturated moisture and visible substrate damage. The subfloor near the tub is classified as Condition 2.

*Paint bubbling, peeling, and drywall delamination at the lower wall adjacent to the toilet supply line. Dark brown to black discoloration consistent with microbial growth at the wall-floor junction. Tan/yellow staining indicates chronic moisture intrusion from a likely slow leak or condensation at the supply valve.*

5. **SHORT-TERM:** Investigate the master bathroom toilet supply line for an active or historic slow leak. Remove the drywall section behind the toilet to assess the extent of substrate damage. A 28% WME reading on a bathroom drywall panel not directly in the path of the primary supply line failure indicates an independent moisture source.

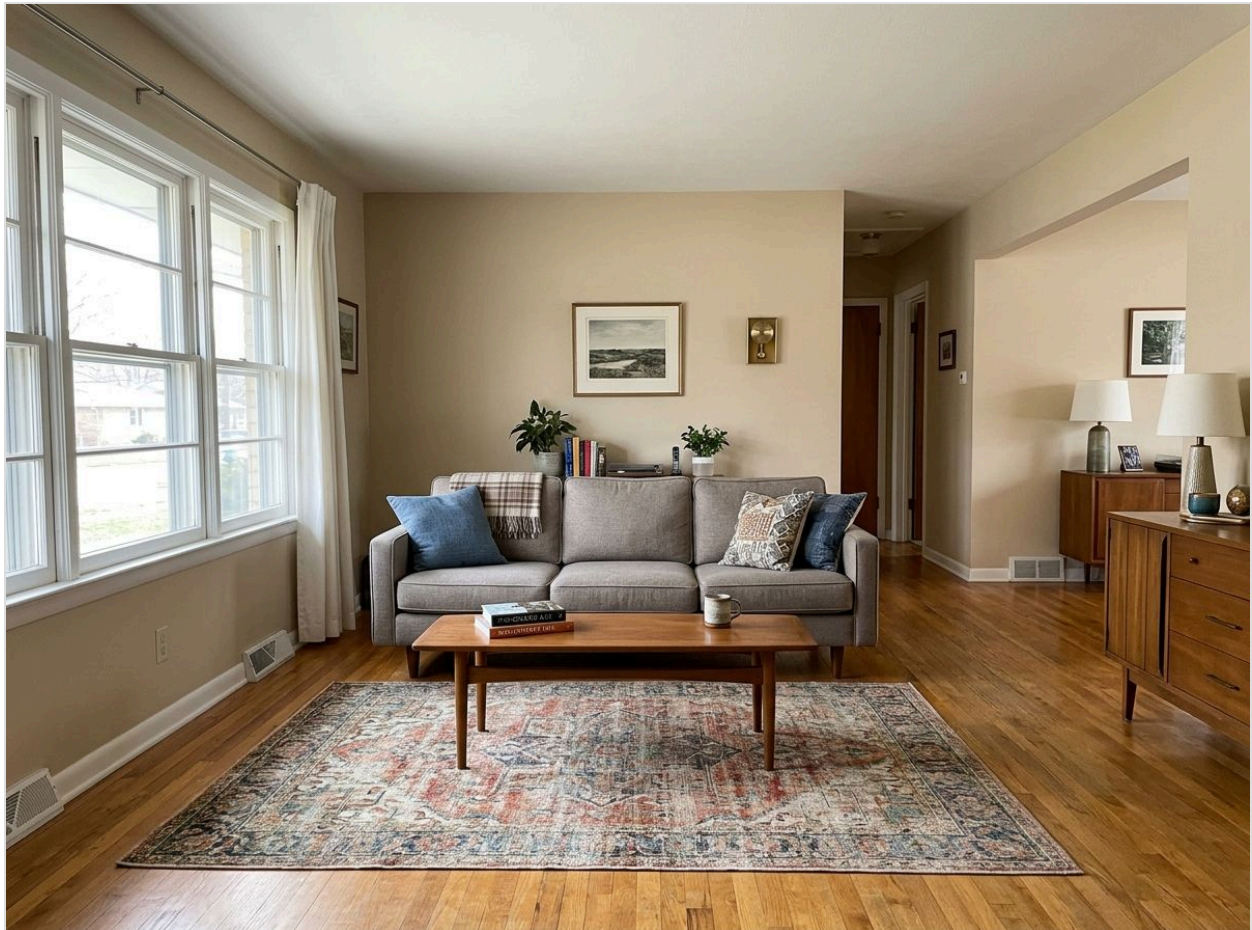
*General overview of the living room. No visible mold growth, water staining, or anomalous discoloration on walls, ceiling, or floor surfaces. Air sample S-004 returned counts within outdoor baseline.*
